MUSCULOSKELETAL PAIN

Avocados to Guacamole Can Be Dangerous: Axis Fracture From Picking Avocados

Deborah Pate, DC, DACBR

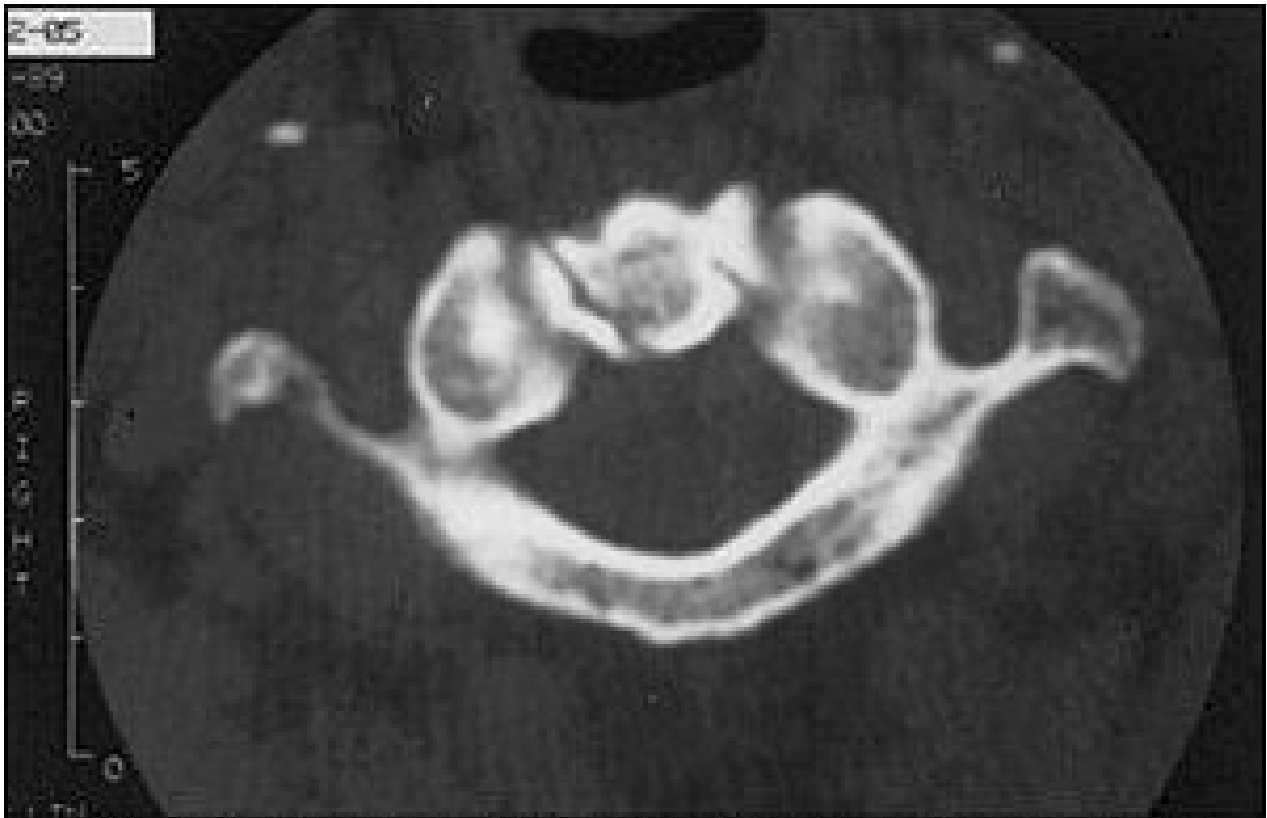
Slice through C1, no fracture.

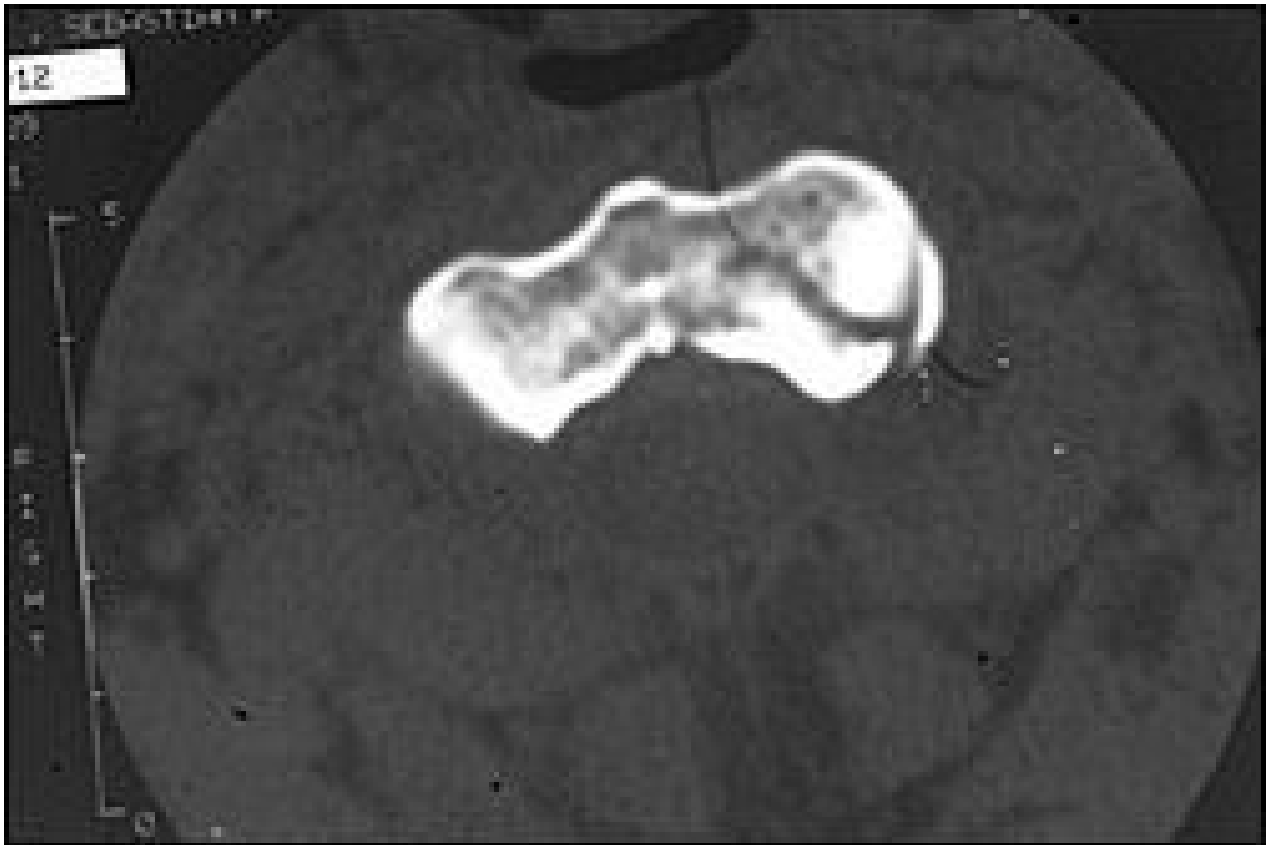
**Slice through C2 at the level of the base of the dens.
Note the fracture line.**

On the CT scan through the C1-2 vertebrae, note the fracture through the dens and the lateral mass of C2. (That was the depression we saw on the APOM of the lateral mass.) Should we look at the APOM view again?

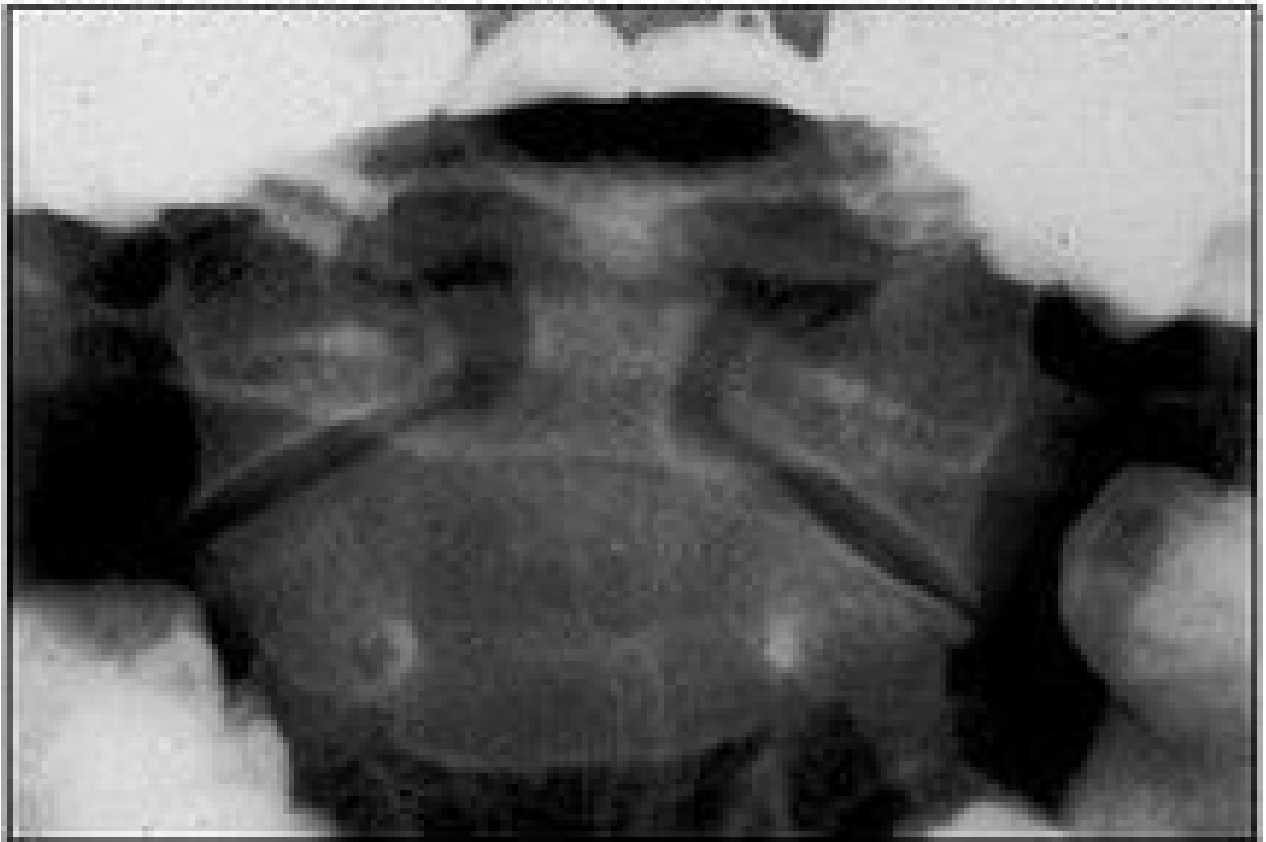
Normal APOM (above) contrasted with APOM of the patient.

This view above evaluates C1-C2, which cannot be visualized clearly on the lateral. The most important element to check is the alignment of the lateral masses of C1. The intervertebral space should be symmetric. The dens can also be evaluated for fracture in this view, but occasionally overlying shadows may give the false impression of a dens fracture (Mach effect). Correlate the findings with the lateral view of the cervical spine. The incidence of fractures to the axis is about 6 percent, and over 50 percent of those fractures involve some part of the dens.
